Minerals Inspection Report

Mine Name: Asphalt Ridge 2	Permit Number: M/47/0032	Mine Status: Inactive
Operator Name: Tar Sands Holdings II	Inspection Date: 05/27/2015	Permit Fees: Delinquent
Inspector(s): A. Abate	Inspection Time: 8 AM	Bond Amount: \$376,000
Attendee(s):	Weather: Clear	Bond Escalation:
Inspection Purpose: Oversee reclamation work at adjacent exploration permit E/47/0066		Prior Inspection: 11/18/2013

Asphalt Ridge 2 M/47/0032

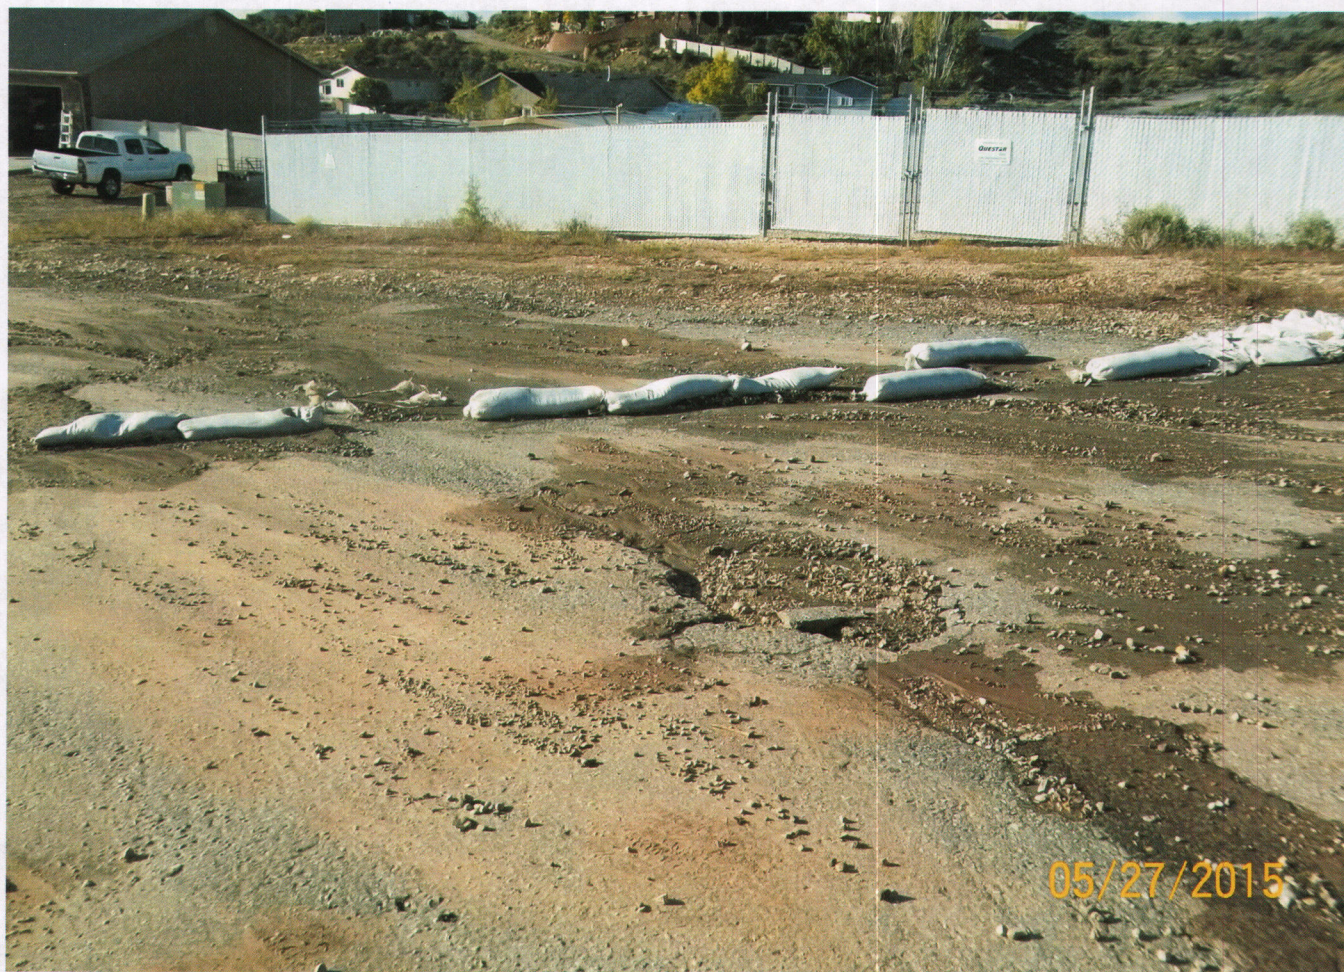
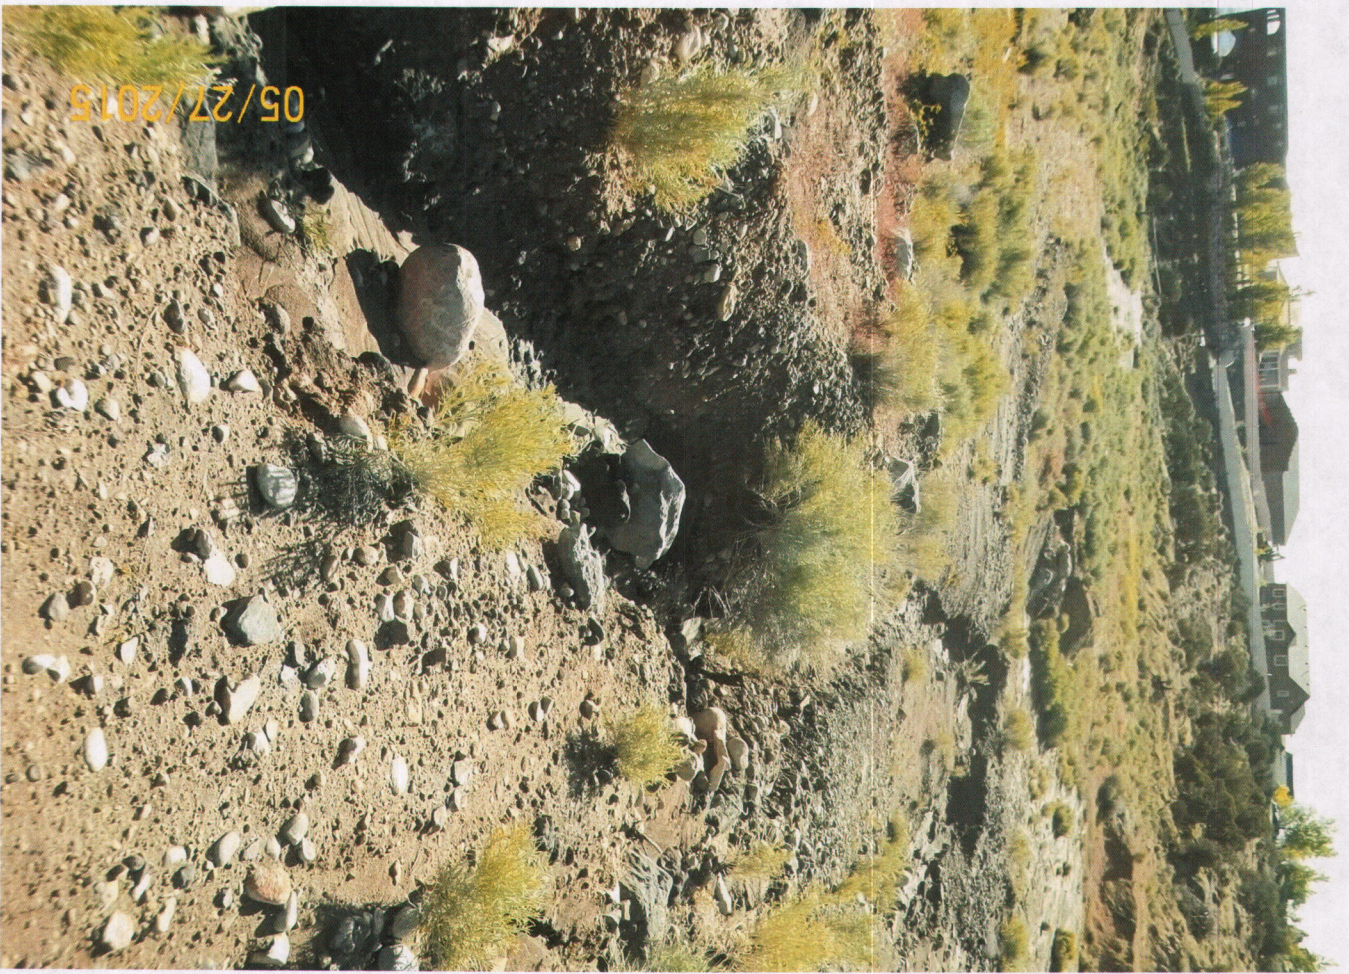
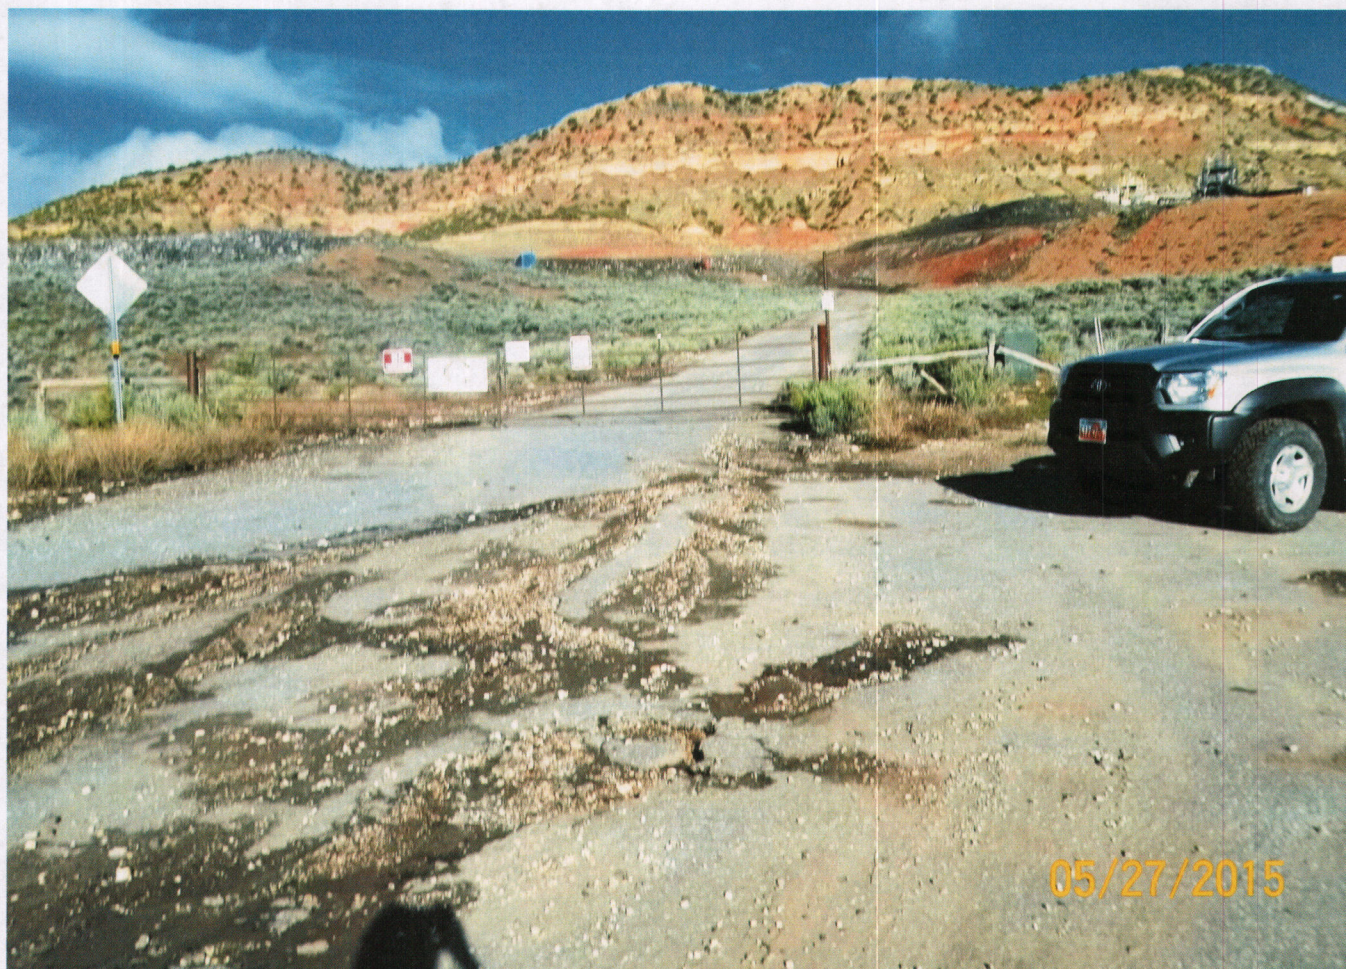
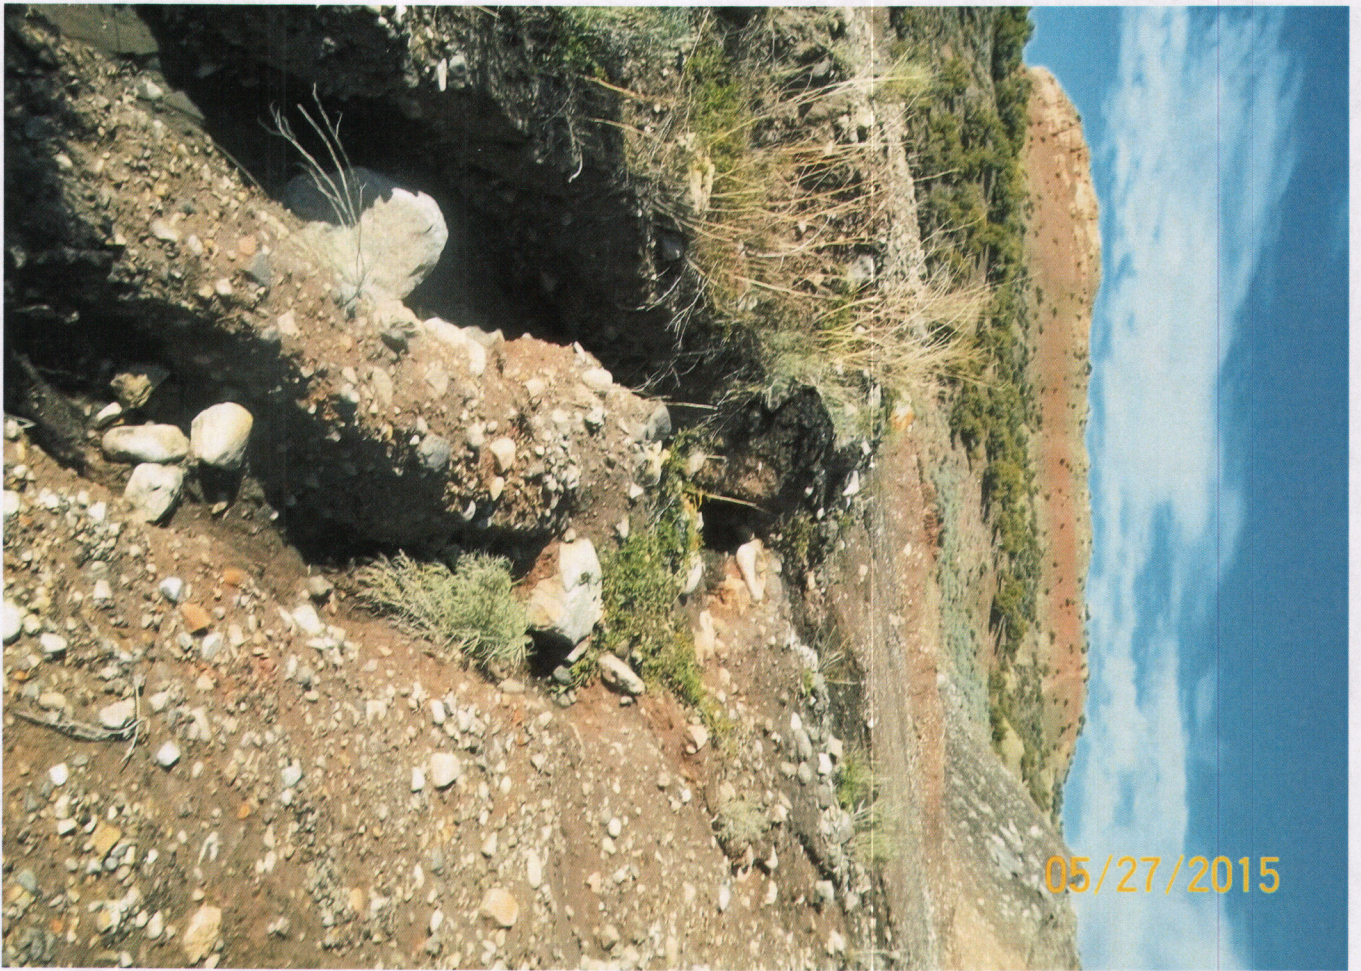
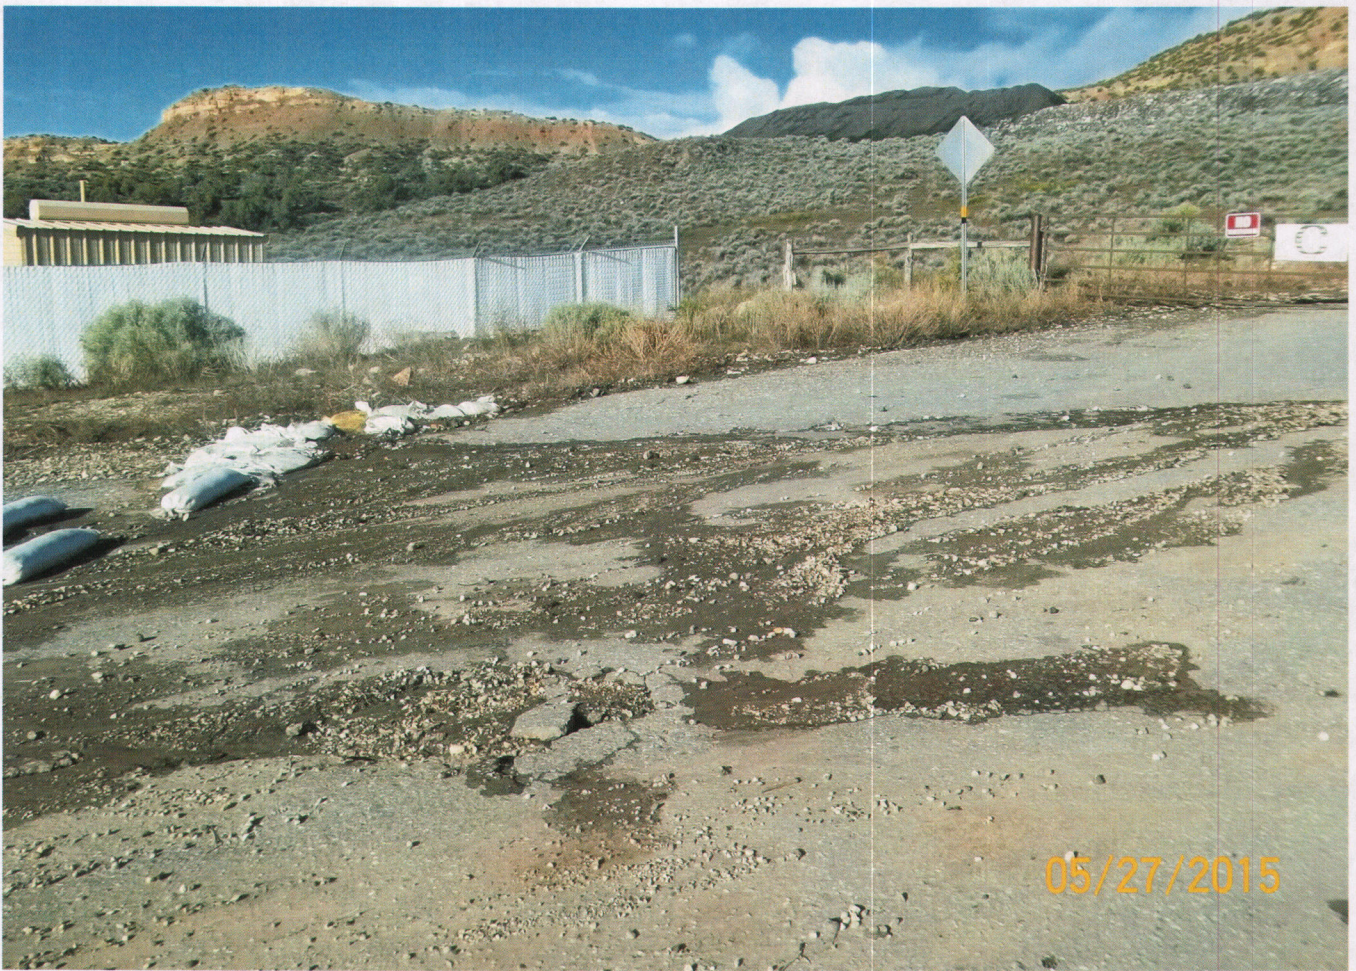
4. <i>Deleterious Material</i>	<input checked="" type="checkbox"/>	<input checked="" type="checkbox"/>
Noticed off-site sediment deposited beyond the mine gate onto the county road leading to the residential area. The county had placed sand bags along the road a few weeks ago according to Rick, the mine caretaker. The source of the material was from the mine. Sediment control is not being maintained on the mine property. A notice of violation is warranted for failure to maintain adequate sediment control. Other areas within the mine are also experiencing major erosion problems. Large rills are forming leading to the existing sediment ponds. Ditches alongside the roads are not being maintained. Culverts are not being maintained. Drainage issues noted in the previous inspection report dated 11/18/2015 do not appear to have been corrected.

Notice of Violation MN-2015-60-02 was issued requiring the operator to address sediment control problems off-site and a plan to maintain sediment control as a commitment to the NOI. The \$500 permit fee for this mine is overdue. A delinquency notice was sent to the operator requiring the fee be paid by 6/30/2015.
